**Flood Control Project Maintenance  
Levee Inspections**

## Maintenance Issue Types Only, Levee Inspection Report By Mile - Spring 2019

### Merced Streams Group

Waterway	Bank	Unit Miles	Inspection Start/End	Inspector
Unit No. 01 Black Rascal Diversion	Right	1.61	04/30/2019 04/30/2019	Corey Fujitani

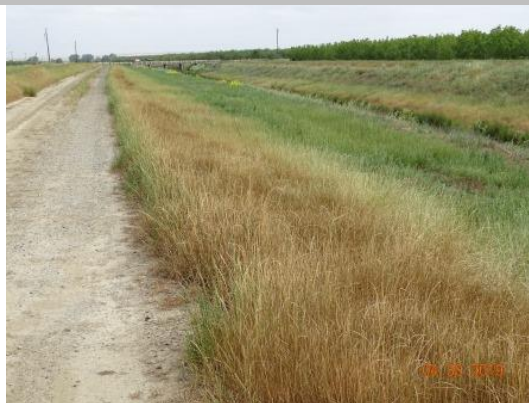
Photo 1 of 1 : SP\_2019\_NA0013\_331\_10\_20190501\_00011.jpg

LM Start	0.01	Rating **	M	Issue No.	10
LM End	1.31	Issue Type +	Ma	Location *	WS
Category	Earthen Levee			GPS Latitude/Longitude	
				Start	End
Item	Vegetation			37.314825 °	37.333014 °
				-120.396403 °	-120.395097 °
DWR ID	DWR_NA0013_01_s_2019_10				
Comment Code					
V1 : Control annual grass and weeds on the levee slopes and easements.					
Inspector Comment

View of waterside slope looking upstream. (Spring 2019)

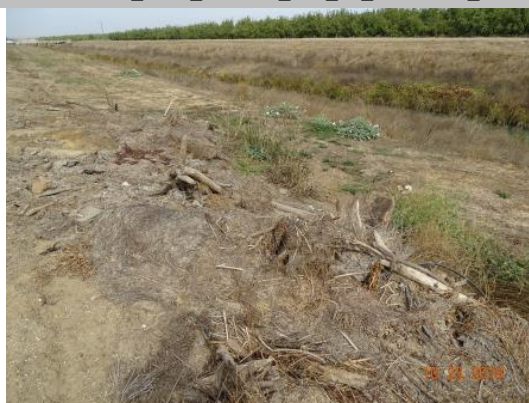
Photo 1 of 1 : SP\_2019\_NA0013\_331\_11\_20190307\_00007.jpg

LM Start	0.02	Rating **	M	Issue No.	11
LM End	0.02	Issue Type +	Ma	Location *	WS
Category	Earthen Levee			GPS Latitude/Longitude	
				Start	End
Item	Encroachments			37.314942 °	37.314942 °
				-120.396394 °	-120.396394 °
DWR ID	DWR_NA0013_01_f_2018_11				
Comment Code					
DE : Debris					
Inspector Comment					
There is garbage on the waterside slope.

Debris and garbage along waterside slope. (Fall 2018)

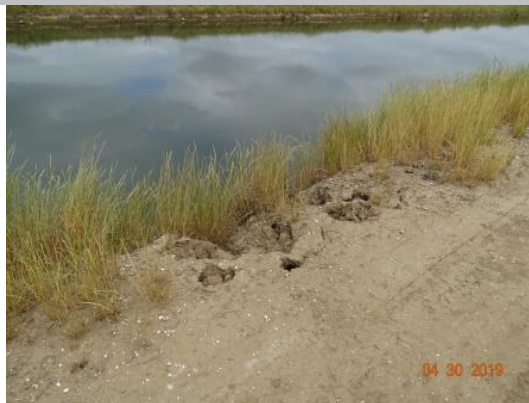
Photo 1 of 1 : SP\_2019\_NA0013\_331\_14\_20190515\_00019.jpg

LM Start	0.75	Rating **	A/W	Issue No.	14
LM End	0.75	Issue Type +	Ma	Location *	LS
Category	Earthen Levee			GPS Latitude/Longitude	
				Start	End
Item	Erosion / Bank Caving			37.325485 °	37.325485 °
				-120.396700 °	-120.396700 °
DWR ID	DWR_NA0013_01_s_2019_14				
Comment Code					
E1 : Note and monitor erosion site.					
Inspector Comment

View of erosion on landside slope. (Spring 2019)

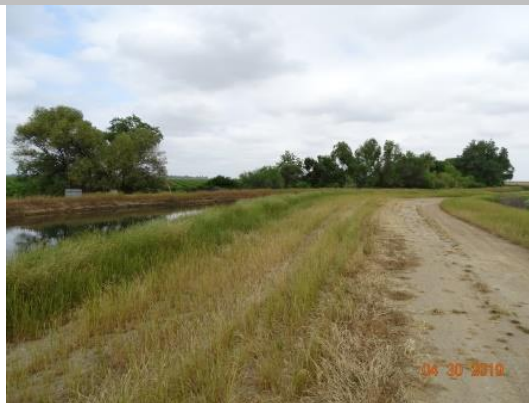
Photo 1 of 1 : SP\_2019\_NA0013\_331\_17\_20190501\_00016.jpg

LM Start	1.25	Rating **	U	Issue No.	17
LM End	1.58	Issue Type +	Ma	Location *	LS
Category	Earthen Levee			GPS Latitude/Longitude	
				Start	End
Item	Vegetation			37.332294 °	37.336724 °
				-120.394732 °	-120.396541 °
DWR ID	DWR_NA0013_01_s_2019_17				
Comment Code					
V1 : Control annual grass and weeds on the levee slopes and easements.					
Inspector Comment

View of landside slope looking upstream. (Spring 2019)

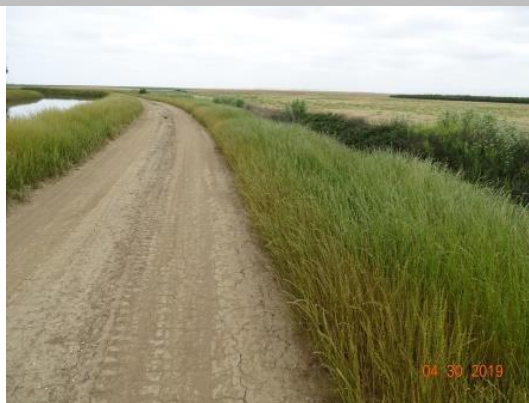
Photo 1 of 1 : SP\_2019\_NA0013\_331\_19\_20190501\_00018.jpg

LM Start	1.32	Rating **	U	Issue No.	19
LM End	1.58	Issue Type +	Ma	Location *	WS
Category	Earthen Levee			GPS Latitude/Longitude	
				Start	End
Item	Vegetation			37.333205 °	37.336734 °
				-120.395142 °	-120.396542 °
DWR ID	DWR_NA0013_01_s_2019_19				
Comment Code					
V1 : Control annual grass and weeds on the levee slopes and easements.					
Inspector Comment

View of waterside slope looking upstream. (Spring 2019)

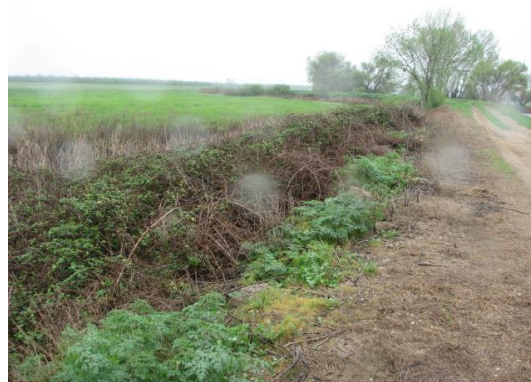
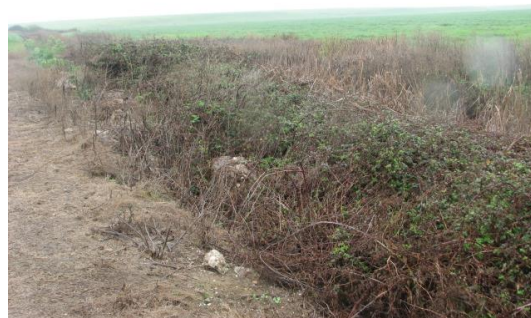
Photo 1 of 2 : SP\_2019\_NA0013\_331\_7\_20190307\_00002.jpg

LM Start	1.57	Rating **	U	Issue No.	7
LM End	1.61	Issue Type +	Ma	Location *	WS
Category	Earthen Levee			GPS Latitude/Longitude	
				Start	End
Item	Vegetation			37.336576 °	37.337098 °
				-120.396540 °	-120.396528 °
DWR ID	DWR_NA0013_01_s _ 2018_7				
Comment Code					
V2 : Remove the wild growth other than native grasses from the levee slopes.					
Inspector Comment					
Remove wild roses from waterward slope.

Looking downstream at wild roses on waterward slope. (Spring 2018)

View of wild roses.

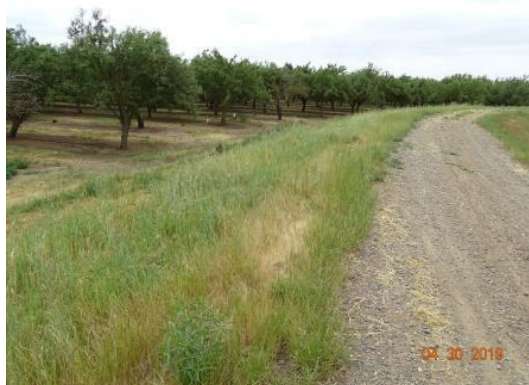
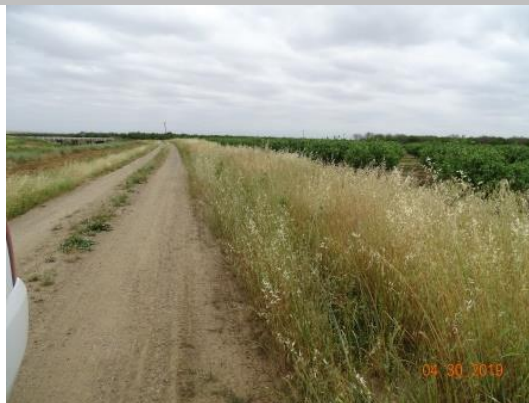
Photo 1 of 2 : SP\_2019\_NA0013\_332\_17\_20190501\_00042.jpg

LM Start	0.41	Rating **	U	Issue No.	17
LM End	0.90	Issue Type +	Ma	Location *	LS
Category	Earthen Levee			GPS Latitude/Longitude	
				Start	End
Item	Vegetation			37.334330 °	37.328360 °
				-120.392537 °	-120.396071 °
DWR ID	DWR_NA0013_02_s_2019_17				
Comment Code					
V1 : Control annual grass and weeds on the levee slopes and easements.					
Inspector Comment

View of landside slope looking downstream. (Spring 2019)

View of landside slope looking upstream. (Spring 2019)

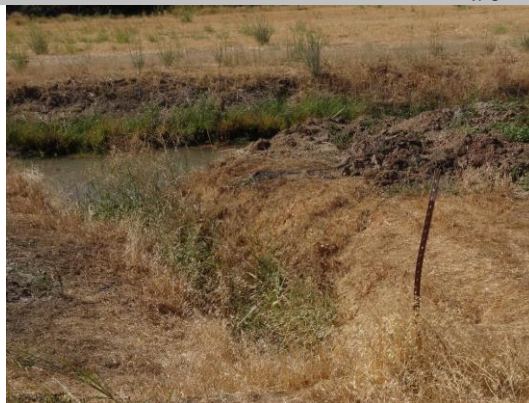
Photo 1 of 3 : UCIP\_SP\_2019\_20946\_35266.jpg

LM Start	0.54	Rating **	M	Issue No.	33
LM End	0.54	Issue Type +	Ma	Location *	
Category	Supplemental			GPS Latitude/Longitude	
				Start	End
Item	DWR UCIP LMA Responsibility			37.333180 °	37.333180 °
				-120.394069 °	-120.394069 °
DWR ID	23054				
Comment Code					
Inspector Comment					
FS_ID:20946 DS_ID:23054 EP_NO: N/A Repair Type: Non-Urgent Crossing Status: Found UCIP Comments: 09/17/2013 - needs vegetation cleaning on both sides.- flap gate was not properly closed during field survey.- inlet needs cleaning. (DWR UCIP - P. Amatya) FIELD_STRUCT_DESC: 24-inch corrugated metal gravity drainage pipe through the levee, 12 feet below the crown. Concrete headwall, flap gate, and concrete grouted cobble spillway on the waterside (WS) toe. Concrete headwall on the landside (LS) toe. [Additional Reference(s): DWR Levee Log, 2005]. FS Date: 9/17/2013

WS view: cobble spillway and channel on waterside.

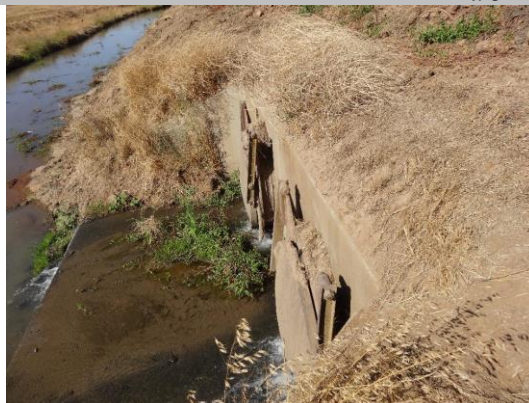
Photo 1 of 3 : UCIP\_SP\_2019\_20983\_35302.jpg

LM Start	0.91	Rating **	A/W	Issue No.	36	
LM End	0.91	Issue Type +	Ma	Location *		
Category	Supplemental			GPS Latitude/Longitude		
				Start		End
Item	DWR UCIP LMA Responsibility			37.328267 °		37.328267 °
				-120.396084 °		-120.396084 °
DWR ID	23080					
Comment Code						
Inspector Comment						
FS_ID:20983 DS_ID:23080 EP_NO: N/A Repair Type: No Action Needed Crossing Status: Found UCIP Comments: 09/17/2013 It was working during field inspection.  Dense vegetation in drainage ditch (DWR UCIP - P. Amatya). FIELD_STRUCT_DESC: 2 of 2: 60-inch corrugated metal gravity drainage pipe through the levee, 10 feet below the crown. Concrete headwall and flap gate on the waterside (WS) berm, 5 feet from the levee toe. Concrete headwall on the landside (LS) toe. [Additional Reference(s): DWR Levee Log, 2005. USACE San Joaquin O&M Manual 607, June 1962, (HLM 0.91)]. FS Date: 9/17/2013

WS view: two CMPs with flap gate, concrete spillway and channel on waterside.

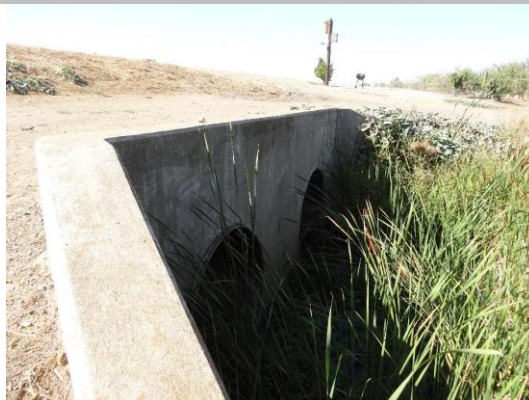
Photo 2 of 3 : UCIP\_SP\_2019\_20983\_35301.jpg

LS view: U typed concrete headwall, two CMPs in drainage ditch. Dense vegetation in drainage ditch.

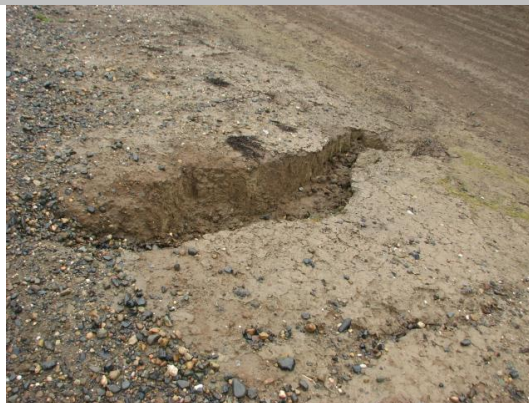
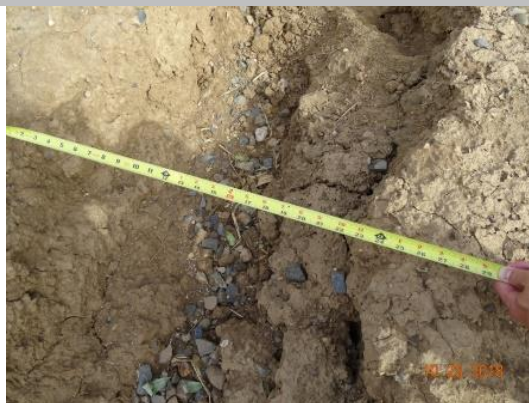
Photo 2 of 3 : SP\_2019\_NA0013\_332\_15\_20190307\_00006.jpg

LM Start	0.97	Rating **	M	Issue No.	15 (cont)	
LM End	0.97	Issue Type +	Ma	Location *	LS	
Category	Earthen Levee			GPS Latitude/Longitude		
				Start		End
Item	Erosion / Bank Caving			37.327336 °		37.327336 °
				-120.396085 °		-120.396085 °
DWR ID	DWR_NA0013_02_f_2017_15					
Comment Code						
E1 : Note and monitor erosion site.						
Inspector Comment						
There is large finger erosion on the landward slope. Couple of smaller erosion sites are starting just downstream of the larger erosion.

Looking downstream at finger erosion on landward slope. (Spring 2018)

Measurement across erosion at widest point. (Fall 2018)

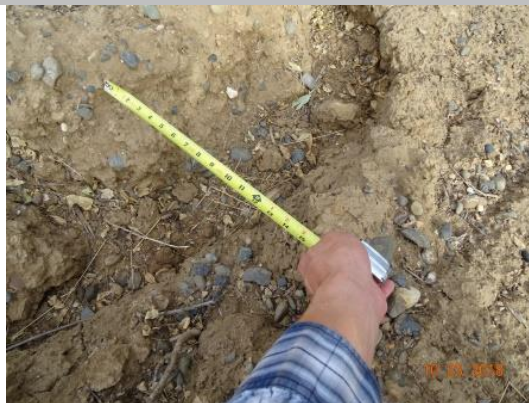
Photo 2 of 2 : SP\_2019\_NA0013\_332\_16\_20190307\_00009.jpg

LM Start	1.10	Rating **	M	Issue No.	16 (cont)	
LM End	1.10	Issue Type +	Ma	Location *	LS	
Category	Earthen Levee			GPS Latitude/Longitude		
				Start		End
Item	Erosion / Bank Caving			37.325487 °		37.325487 °
				-120.396052 °		-120.396052 °
DWR ID	DWR_NA0013_02_s_2017_16					
Comment Code						
E1 : Note and monitor erosion site.						
Inspector Comment						
Large finger erosion is located on the landside slope.

Measurement across finger erosion. (Fall 2018)

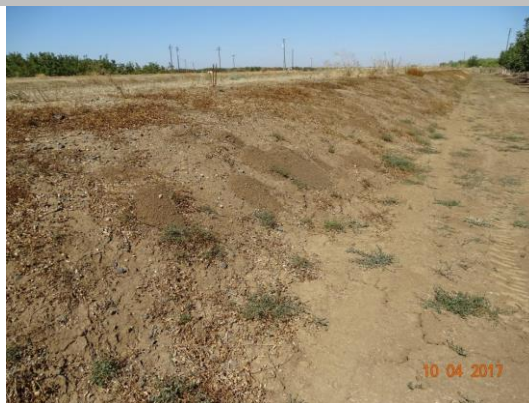
Photo 1 of 1 : SP\_2019\_NA0013\_332\_18\_20190307\_00010.jpg

LM Start	1.30	Rating **	M	Issue No.	18
LM End	1.85	Issue Type +	Ma	Location *	LS
Category	Earthen Levee			GPS Latitude/Longitude	
				Start	End
Item	Animal Control			37.322518 °	37.314652 °
				-120.396042 °	-120.395827 °
DWR ID	DWR_NA0013_02_f_2017_18				
Comment Code					
A3 : No rodents visible, but rodent burrows visible; need to backfill and compact or grout burrows.					
Inspector Comment					
There is rodent activity on the landside slope.

View of rodent activity on the landside slope.

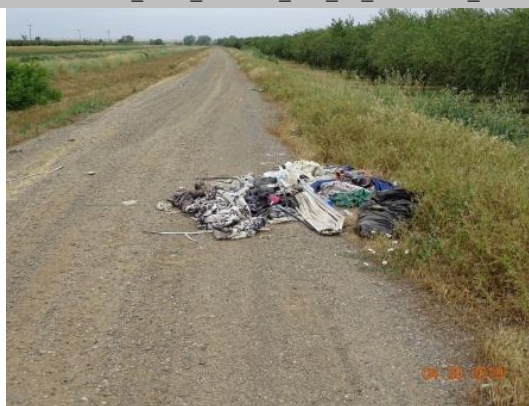
Photo 1 of 1 : SP\_2019\_NA0013\_332\_29\_20190501\_00047.jpg

LM Start	1.52	Rating **	M	Issue No.	29
LM End	1.52	Issue Type +	Ma	Location *	CR
Category	Earthen Levee			GPS Latitude/Longitude	
				Start	End
Item	Encroachments			37.319367 °	37.319367 °
				-120.396030 °	-120.396030 °
DWR ID	DWR_NA0013_02_s_2019_29				
Comment Code					
GA : Garbage					
Inspector Comment					
There is trash left on the waterside of the levee crown.

Trash left on waterside of levee crown. (Spring 2019)

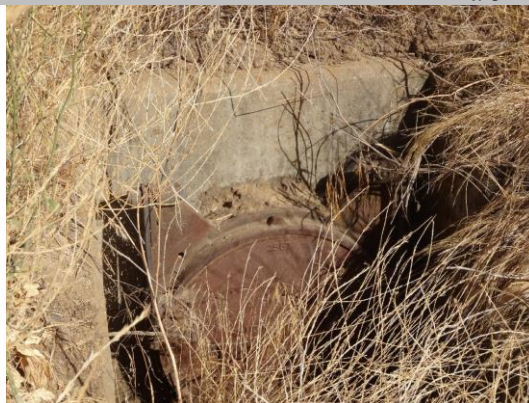
Photo 2 of 3 : UCIP\_SP\_2019\_42993\_35309.jpg

WS view: U typed concrete headwall, CM pipe and flap gate. Vegetation and debris need to be cleared.

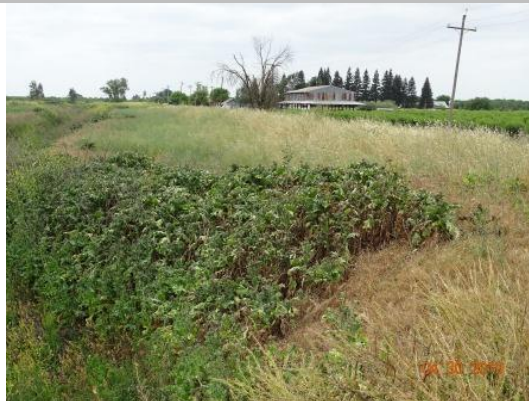
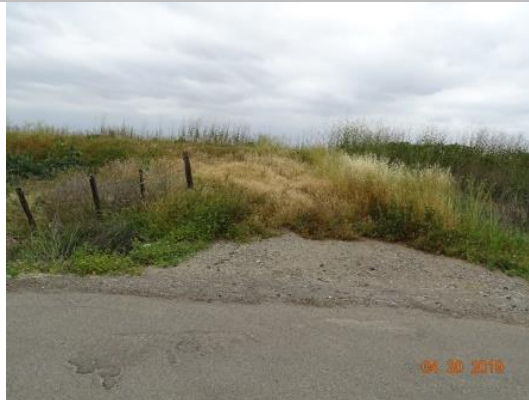
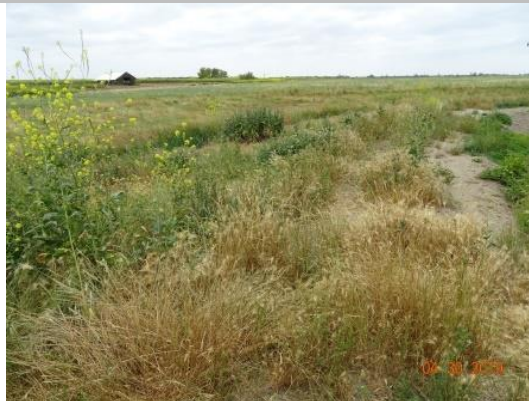
Photo 1 of 3 : SP\_2019\_NA0013\_333\_13\_20190503\_00027.jpg

LM Start	0.00	Rating **	U	Issue No.	13
LM End	1.26	Issue Type +	Ma	Location *	WS
Category	Earthen Levee			GPS Latitude/Longitude	
				Start	End
Item	Vegetation			37.257654 °	37.272941 °
				-120.288501 °	-120.280324 °
DWR ID	DWR_NA0013_03_s_2019_13				
Comment Code					
V1 : Control annual grass and weeds on the levee slopes and easements.					
Inspector Comment

View of waterside slope looking downstream at access point at the intersection of S Burchell Ave and Santa Fe Ave. (Spring 2019)

View of access point looking upstream near S Burchell Ave and railroad crossing along Santa Fe Ave. (Spring 2019)

View of waterside slope looking downstream at access point on Mission Ave. (Spring 2019)

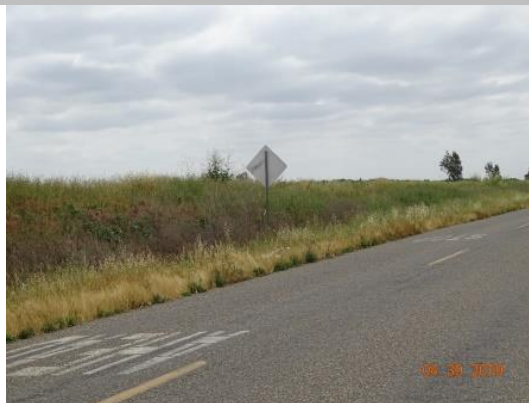
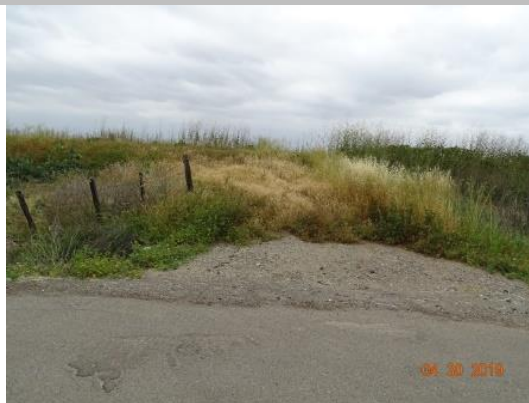
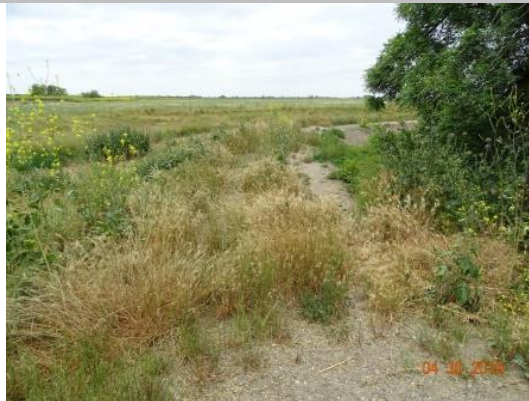
Photo 1 of 3 : SP\_2019\_NA0013\_333\_12\_20190503\_00030.jpg

LM Start	0.00	Rating **	U	Issue No.	12
LM End	1.26	Issue Type +	Ma	Location *	LS
Category	Earthen Levee			GPS Latitude/Longitude	
				Start	End
Item	Vegetation			37.257654 °	37.272941 °
				-120.288501 °	-120.280302 °
DWR ID	DWR_NA0013_03_s_2019_12				
Comment Code					
V1 : Control annual grass and weeds on the levee slopes and easements.					
Inspector Comment

View of landside slope looking downstream from S Burchell Ave. (Spring 2019)

View of access point looking upstream near S Burchell Ave and railroad crossing along Santa Fe Ave. (Spring 2019)

View of landside slope looking downstream at the Mission Ave access point. (Spring 2019)

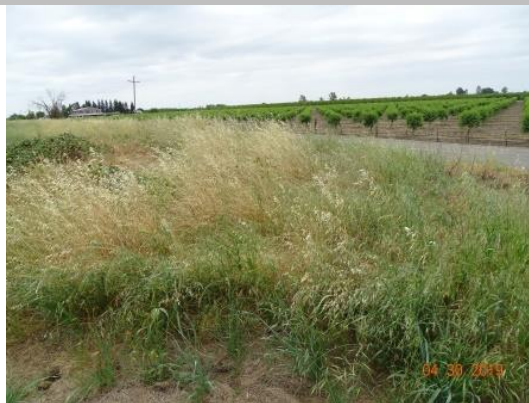
Photo 1 of 3 : SP\_2019\_NA0013\_333\_17\_20190503\_00033.jpg

LM Start	0.00	Rating **	U	Issue No.	17
LM End	1.26	Issue Type +	Ma	Location *	CR
Category	Earthen Levee			GPS Latitude/Longitude	
				Start	End
Item	Vegetation			37.257654 °	37.272941 °
				-120.288501 °	-120.280302 °
DWR ID	DWR_NA0013_03_s_2019_17				
Comment Code					
V9 : Keep the crown roadway free of vegetation.					
Inspector Comment

View of levee crown looking downstream at access point near S Burchell Ave and Santa Fe Ave. (Spring 2019)

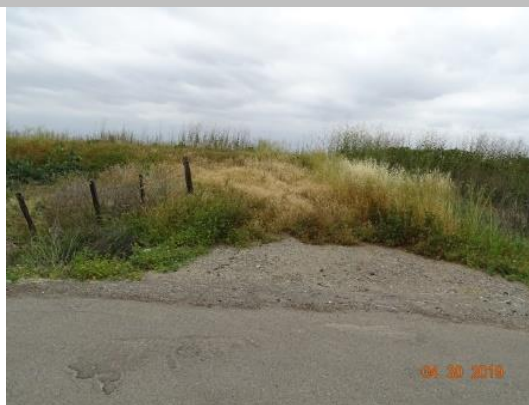
Photo 2 of 3 : SP\_2019\_NA0013\_333\_17\_20190503\_00035.jpg

View of levee crown looking upstream at access point North of S Burchell and Santa Fe intersection. (Spring 2019)

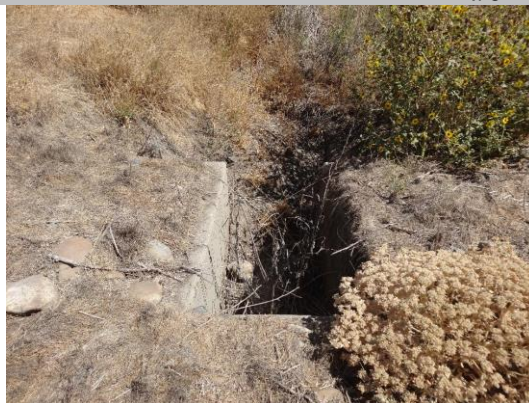
Photo 1 of 3 : UCIP\_SP\_2019\_50144\_35422.jpg

Comment Code					
Inspector Comment					
FS_ID:50144 DS_ID:23061 EP_NO: N/A Repair Type: No Action Needed Crossing Status: Found UCIP Comments: 09/01/2016: Crossing has been downgraded from Urgent to No Action Needed. (K. Fazel - UCIP)09/01/2016: Not abandoned. LS and WS cleared. Gate swings free. Photos uploaded. (M. Walejko - NA0013)08/23/2016: Same as last inspection. (K. Fazel - UCIP)09/17/2013:Appears to be abandoned. Flapgate blocked by debris.- debris blocked inlet pipe on LS.- Needs to be cleared on both sides or it needs to abandoned properly. (P. Amatya - UCIP) FIELD_STRUCT_DESC: 24-inch corrugated metal gravity drainage pipe through the levee, 10 feet below the crown. Concrete headwall, flap gate, and concrete grouted cobble spillway on the waterside (WS) toe. Concrete headwall on the landside (LS) toe. [Additional Reference(s): DWR Levee Log, 2005. USACE San Joaquin O&M Manual 607, June 1962, (HLM 0.40)]. FS Date: 9/1/2016

WS view: U typed concrete headwall, cobble spillway, and channel on waterside.

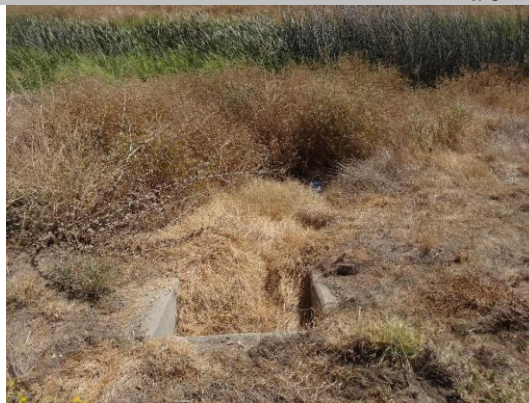
Photo 1 of 3 : UCIP\_SP\_2019\_50152\_35544.jpg

Comment Code						
Inspector Comment						
FS_ID:50152 DS_ID:23064 EP_NO: N/A Repair Type: Non-Urgent Crossing Status: Found UCIP Comments: 09/29/2016: WS outlet has been cleared by NA0013. Crossing will be downgraded from Non-Urgent to No Action Needed upon receipt of photo showing cleared LS. (K. Fazel - UCIP)09/2013:- vegetations need to be removed from spillway and outlet at flapgate (blocked). It needs clearing.- more than half of intet pipe was burried in inlet. It needs cleaning & clearing. (P. Amatya - UCIP) FIELD_STRUCT_DESC: 24-inch corrugated metal gravity drainage pipe through the levee, 5 feet below the crown. Concrete headwall, flap gate, and concrete grouted cobble spillway on the waterside (WS) toe. Concrete headwall on the landside (LS) toe. [Additional Reference(s): DWR Levee Log, 2005. USACE San Joaquin O&M Manual 607, June 1962, (HLM 1.04), O&M Manual reads "HLM 0.04" by mistake]. FS Date: 9/7/2016

WS view: cobble spillway and channel on waterside.

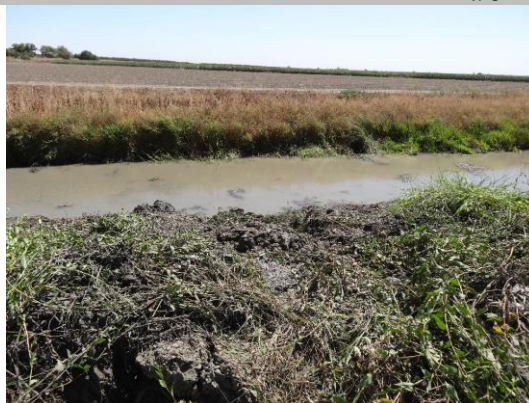
Photo 1 of 3 : UCIP\_SP\_2019\_21063\_35502.jpg

WS view: U typed concrete headwall, CM pipe, and flap gate buried under mud/debris.

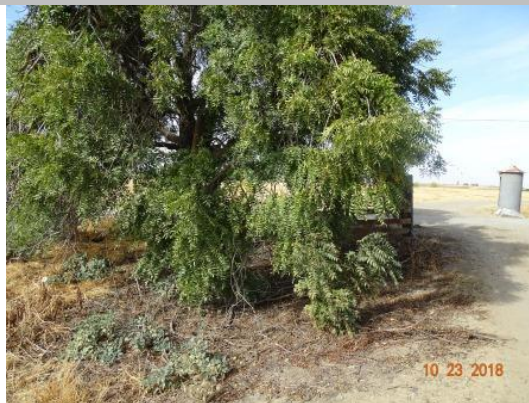
Photo 1 of 1 : SP\_2019\_NA0013\_333\_16\_20190307\_00005.jpg

LM Start	1.25	Rating **	M	Issue No.	16
LM End	1.25	Issue Type +	Ma	Location *	LS
Category	Earthen Levee			GPS Latitude/Longitude	
				Start	End
Item	Trim / Thin Trees			37.272801 °	37.272801 °
				-120.280304 °	-120.280304 °
DWR ID	DWR_NA0013_03_f_2018_16				
Comment Code					
T1 : Trim trees to at least five feet above ground level.					
Inspector Comment

tree on landside slope. (Fall 2018)

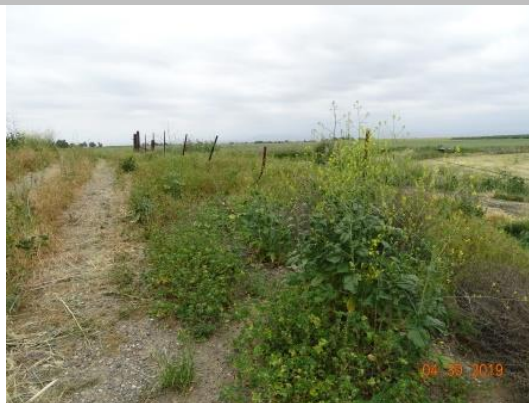
Photo 2 of 2 : SP\_2019\_NA0013\_334\_23\_20190503\_00036.jpg

LM Start	0.15	Rating **	U	Issue No.	23 (cont)	
LM End	1.03	Issue Type +	Ma	Location *	LS	
Category	Earthen Levee			GPS Latitude/Longitude		
				Start		End
Item	Vegetation			37.272888 °		37.262809 °
				-120.279992 °		-120.287890 °
DWR ID	DWR_NA0013_04_s_2019_23					
Comment Code						
V1 : Control annual grass and weeds on the levee slopes and easements.						
Inspector Comment

View of landside slope looking upstream. (Spring 2019)

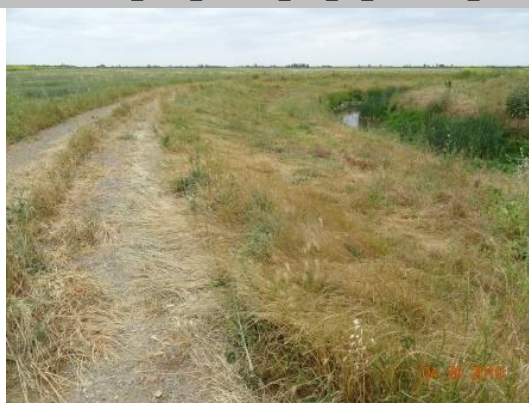
Photo 1 of 2 : SP\_2019\_NA0013\_334\_24\_20190503\_00037.jpg

LM Start	0.15	Rating **	U	Issue No.	24
LM End	1.03	Issue Type +	Ma	Location *	WS
Category	Earthen Levee			GPS Latitude/Longitude	
				Start	End
Item	Vegetation			37.272887 °	37.262809 °
				-120.279997 °	-120.287890 °
DWR ID	DWR_NA0013_04_s_2019_24				
Comment Code					
V1 : Control annual grass and weeds on the levee slopes and easements.					
Inspector Comment

View of waterside slope looking downstream. (Spring 2019)

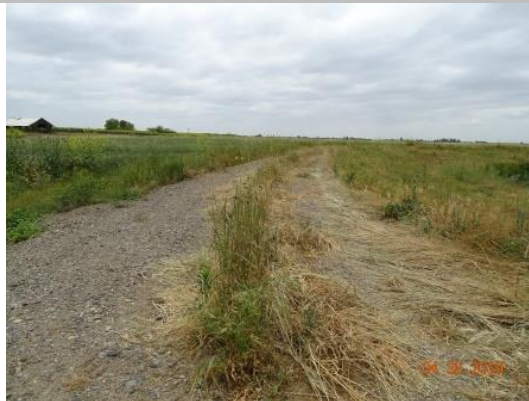
Photo 1 of 2 : SP\_2019\_NA0013\_334\_25\_20190503\_00039.jpg

LM Start	0.15	Rating **	U	Issue No.	25
LM End	1.03	Issue Type +	Ma	Location *	CR
Category	Earthen Levee			GPS Latitude/Longitude	
				Start	End
Item	Vegetation			37.272885 °	37.262808 °
				-120.280000 °	-120.287890 °
DWR ID	DWR_NA0013_04_s_2019_25				
Comment Code					
V9 : Keep the crown roadway free of vegetation.					
Inspector Comment

View of vegetation on levee crown looking downstream. (Spring 2019)

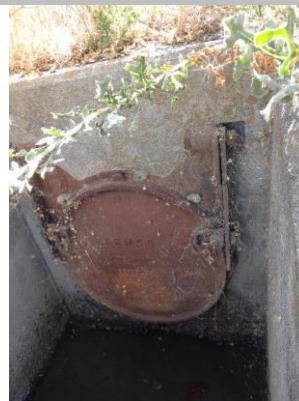
Photo 2 of 3 : UCIP\_SP\_2019\_50148\_35612.jpg

WS view: U typed concrete headwall, CM pipe, and flap gate.

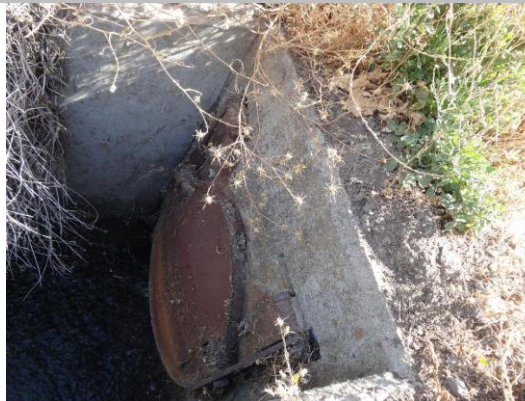
Photo 2 of 3 : UCIP\_SP\_2019\_21126\_35651.jpg

WS view: U typed concrete headwall, CM pipe, and flap gate. Vegetation needs to be cleared on spillway.

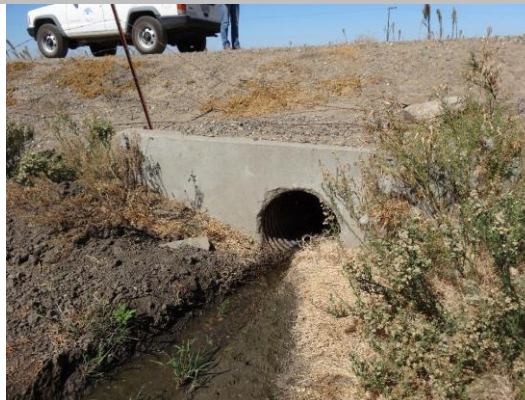
Photo 3 of 3 : UCIP\_SP\_2019\_21126\_35654.jpg

LS view: concrete headwall and CM pipe. Drain pipe was working during field survey.

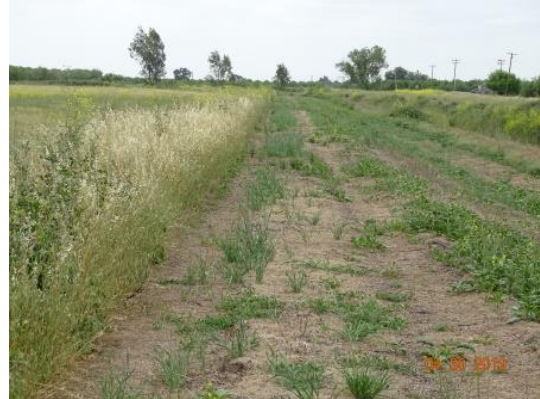
Photo 1 of 1 : SP\_2019\_NA0013\_334\_14\_20190503\_00042.jpg

LM Start	1.08	Rating **	M	Issue No.	14
LM End	1.41	Issue Type +	Ma	Location *	CR
Category	Earthen Levee			GPS Latitude/Longitude	
				Start	End
Item	Vegetation			37.262196 °	37.257476 °
				-120.288137 °	-120.288147 °
DWR ID	DWR_NA0013_04_s_2019_14				
Comment Code					
V9 : Keep the crown roadway free of vegetation.					
Inspector Comment

View of vegetation along levee crown. (spring 2019)
